Manhole Inspection Summary

Manhole # S09II2006MH

Location Address: **6306 IVYMOUNT RD**

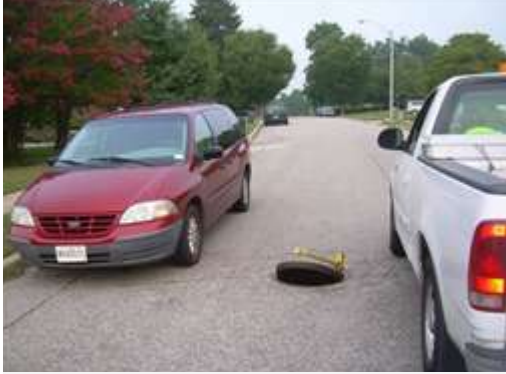
Location View

Comments **Cracks in pavement around manhole. May be a source of infiltration.**

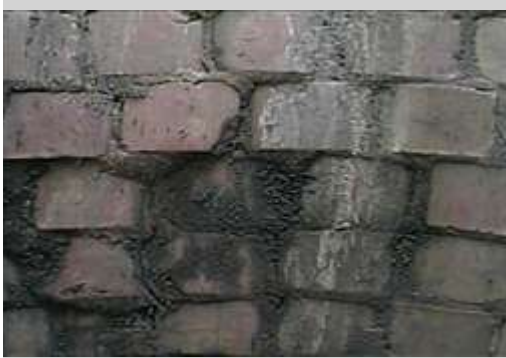
Defect

Barrel infiltration.

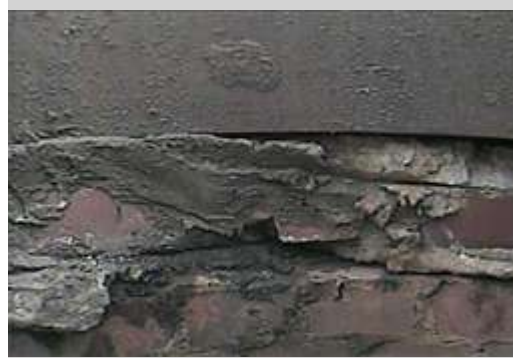
Defect

Frame Offset: **0** (in.) Condition: ☐ Sound ☐ Cracked ☒ **Leaks**

Infiltration: ☐ None ☒ **Joint** ☐ Cracks ☒ **Mortar** ☐ Roots ☐ Wall

Frame leaks. Adjustment infiltration.

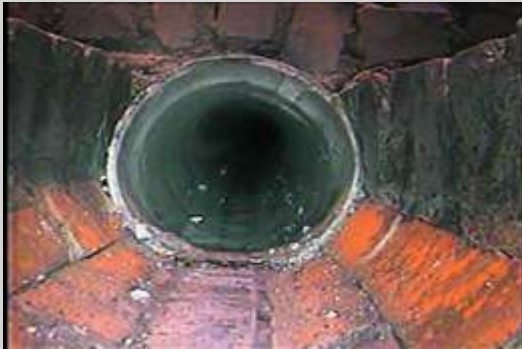
8 in. Circular Gravity Sewer Pipe Out @ 12 O'Clock

Infiltration: **Evidence** Pipe Seal Cond: **Broken**
